## Wetlands Evaluation Report

### **State Road 87 Connector PD&E Study Limits: From the Intersection of SR 87S and US 90 to SR 87 N**

**Project: SR 87 Connector PD&E**

**ERC #: 09-143**

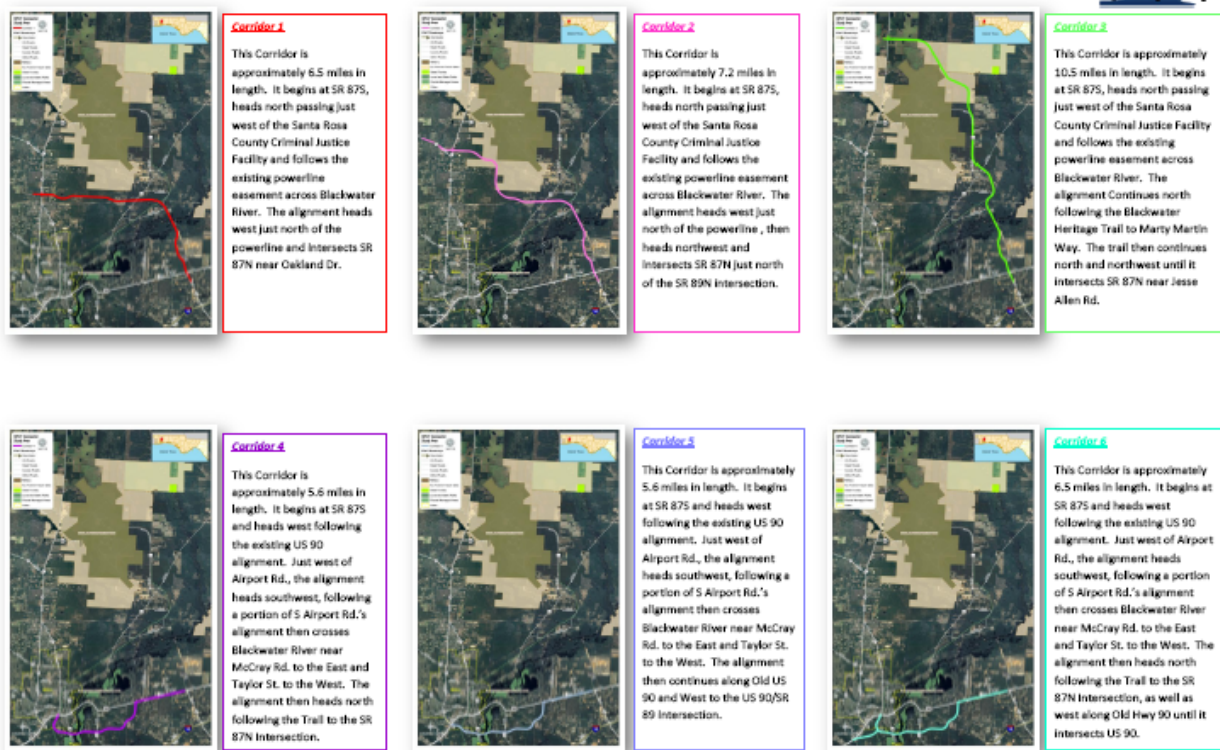
Figure 2.1 Corridor Maps

Six different alignment alternatives and the no-build alternative were evaluated during the alternatives phase of the PD&E. The alternatives evaluation and the figure below, depicting the six original alignments, were documented in the *Corridors Alternative Evaluation Summary Report* (Metric Engineering, 2011).

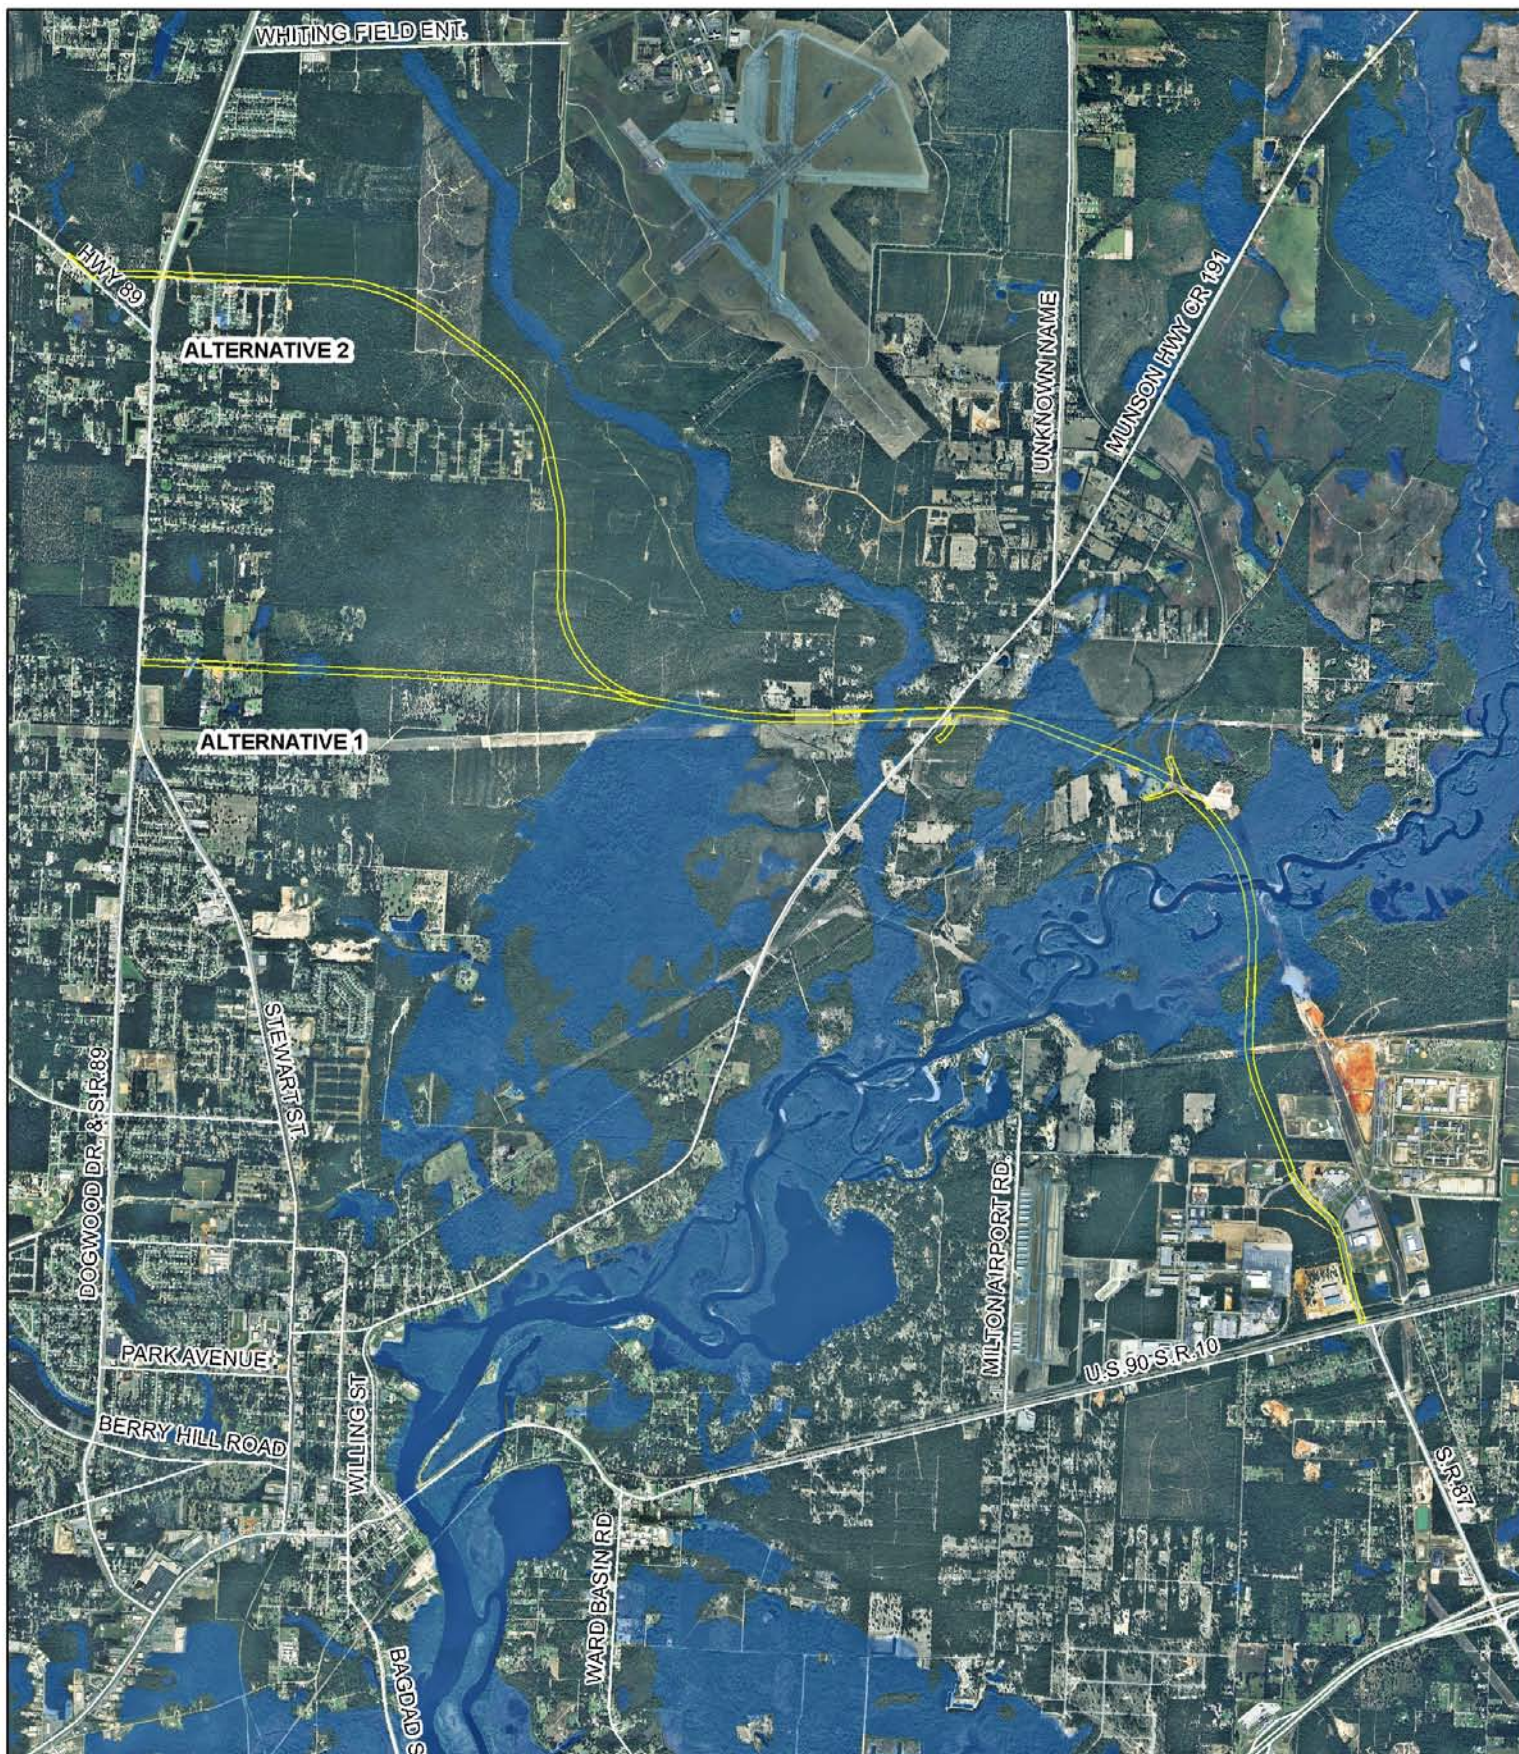
**Figure 2 Wetlands per NWI**

- National Wetlands Inventory (USFWS, 2010)
- Alignments

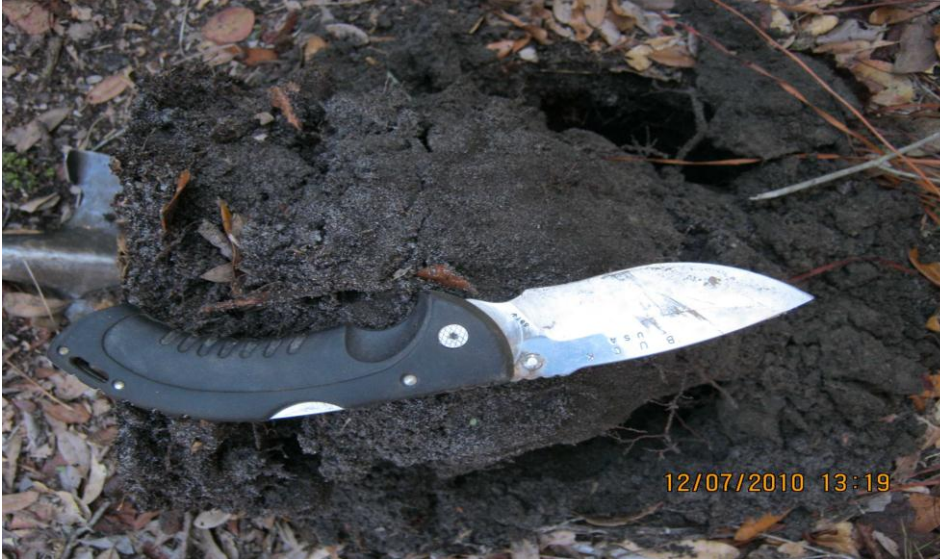
#### **A. 1 - Albany Loamy Sand; 0-5% Slopes**

0-3"	A	10YR 3/2 Sand
3"-8"	E1	10YR 3/1 Loamy Sand
8"-12"+	E2	10YR 4/4 Loamy Sand

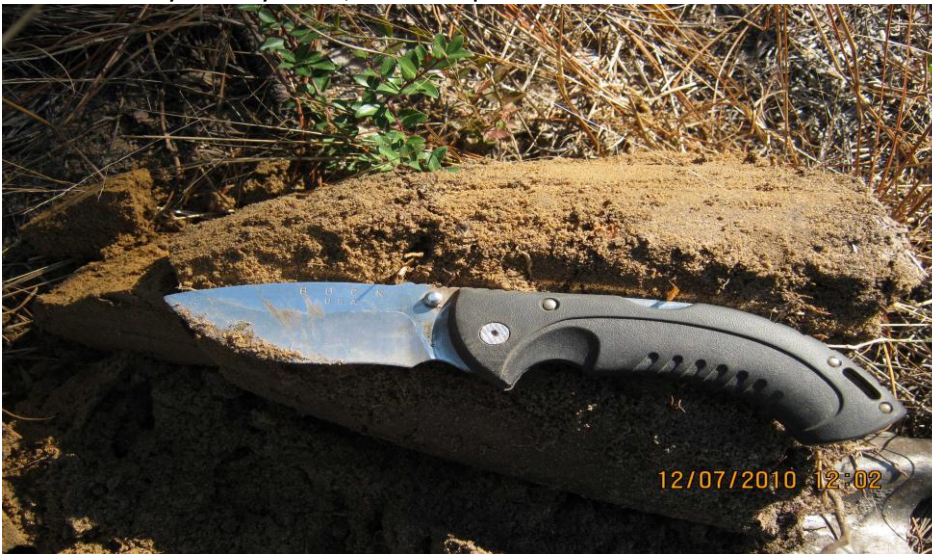
#### **B. 5 - Bonifay Loamy Sand; 0-5% Slopes**

0-12"+	A	10YR 5/4 Loamy Sand
--------	---	---------------------

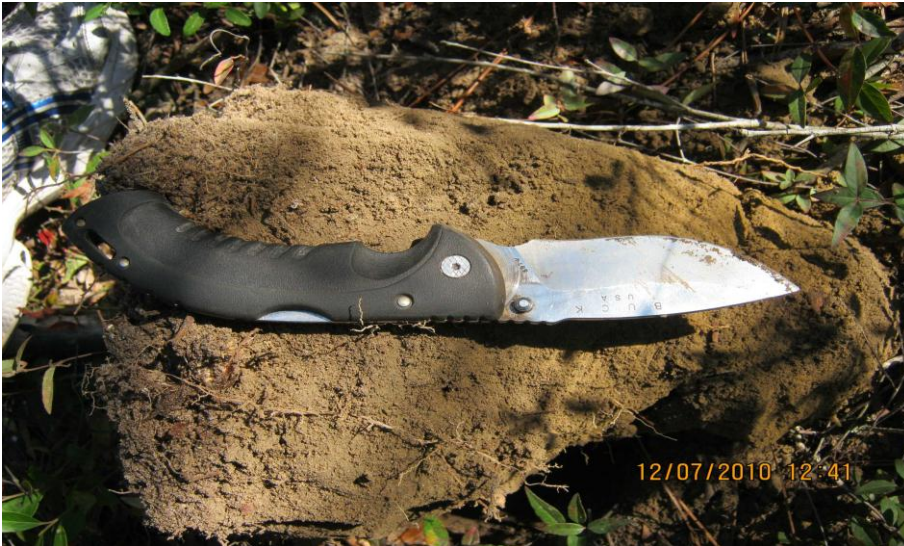
C. 9 - Dothan Fine Sandy Loam; 2-5% Slopes

0-1"	A	10YR 5/2 Sandy Loam
1"-6"	E1	10YR 4/3 Sandy Loam
6"-12"+	E2	10YR 5/6 Sandy Loam

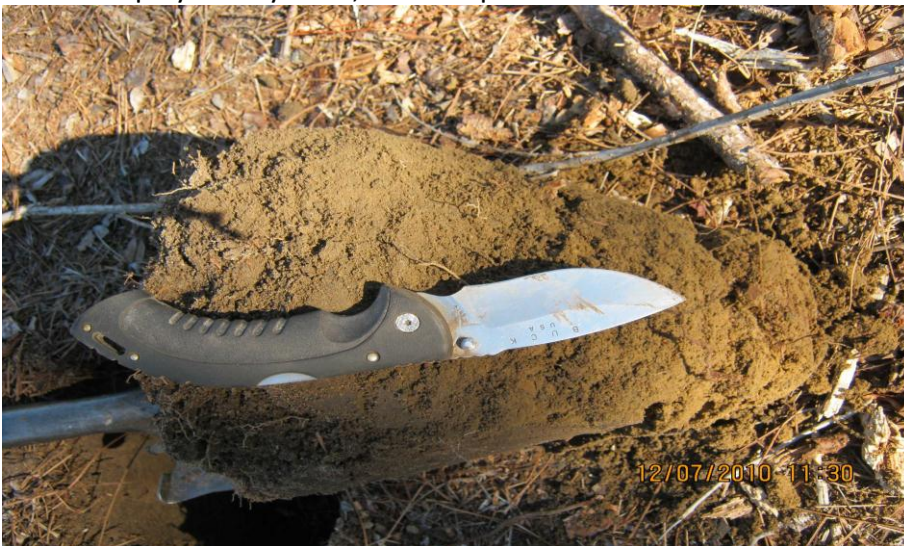
D. 14 - Fuquay Loamy Sand; 0-5% Slopes

0-0.25"	Oi	10YR 2.5/1 Pine Duff
0.25"-6"	A	10YR 3/3 Loamy Sand
6"-12"+	E	10YR 4/4 Loamy Sand

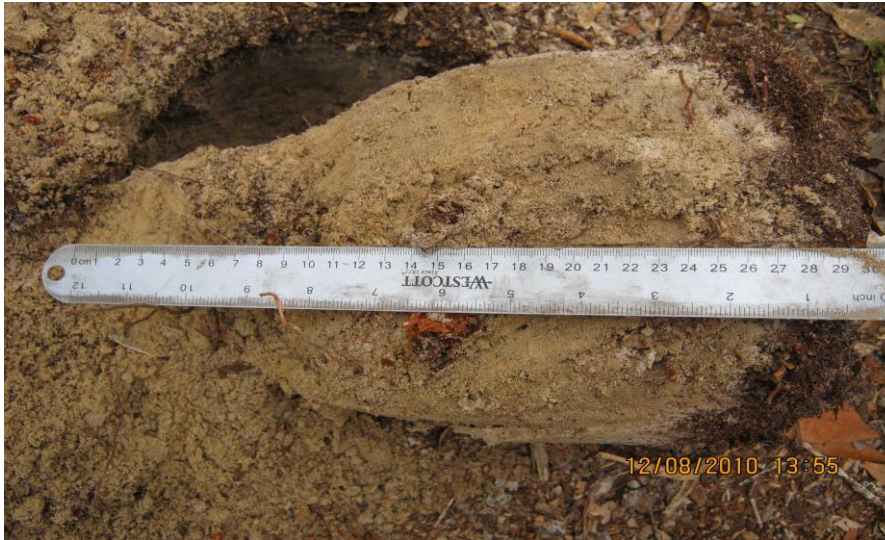
### E. 19 - Kalmia Loamy Fine Sand; 2-5% Slopes

0-1"	Oi	10R 2.5/1 Pine Duff
1"-4"	AE1	10YR 7/1 Loamy Fine Sand w/ 10YR 6/2 Loamy Fine Sand
4"-8"	AE2	10YR 5/4 Loamy Fine Sand w/ 10YR 6/4 Loamy Fine Sand
8"-12"+	E	10YR 6/4 Loamy Fine Sand

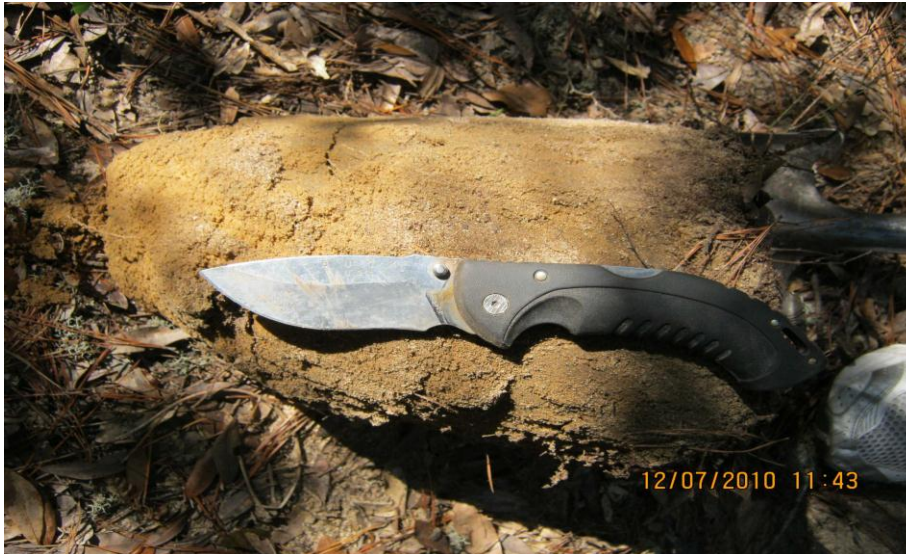
### F. 21 - Lakeland Sand; 0-5% Slopes

0-0.25"	Oi	10R 2.5/1 Pine Duff
0.25"-1.5"	A	10YR 6/4 Loamy Sand
1.5"-5"	AE	10YR 5/4 Loamy Sand
5"-12"+	E	10YR 5/6 Loamy Sand

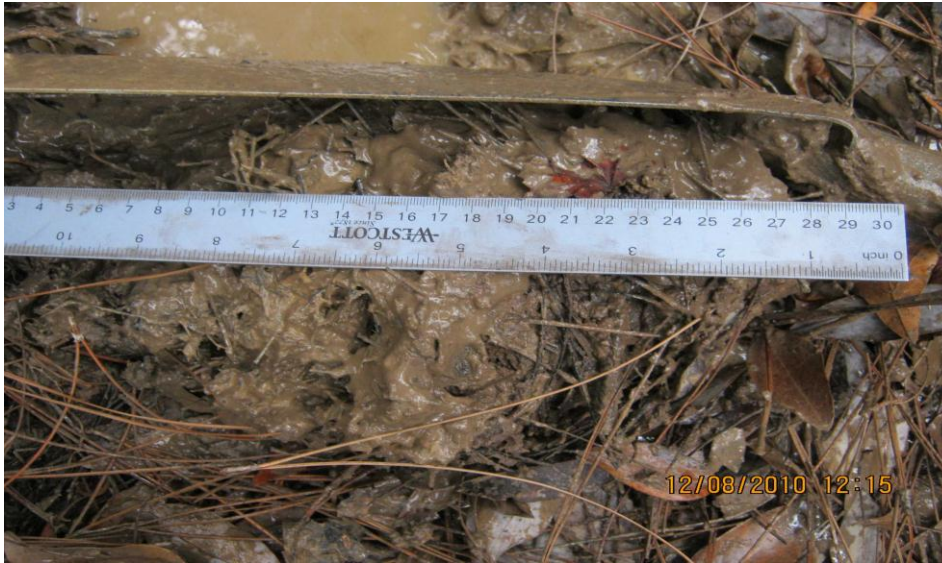
G. 22 - Lakeland Sand; 5-12% Slopes

0-2"	Oi	10YR 5/3 Leaf Litter Layer
2"-12"+	A	10YR 5/3 Sand

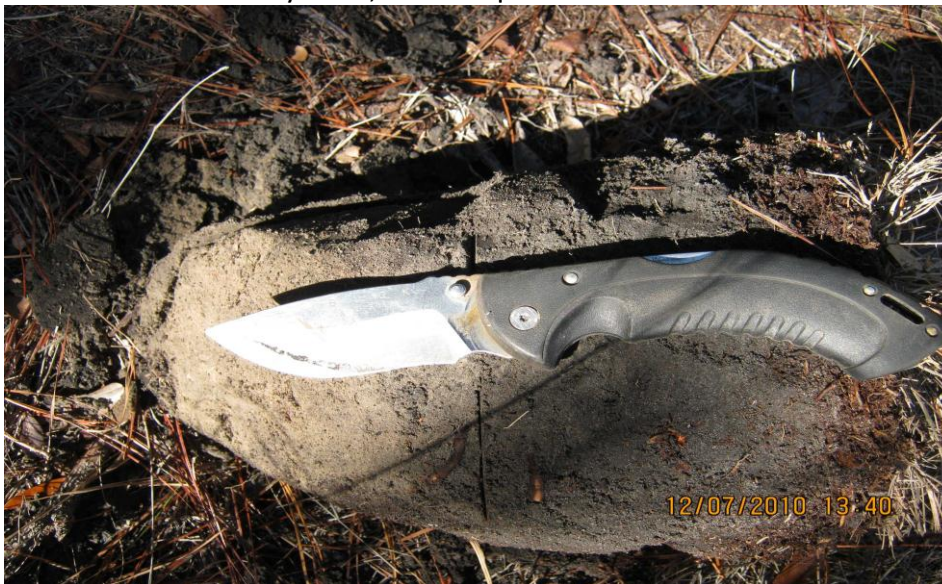
H. 34 - Pactolus Loamy Sand; 0-5% Slopes

0-1"	Oi	10R 2.5/1 Pine Duff
1"-5"	A	10YR 2/1 Loamy Sand
5"-12"+	E	10YR 4/2 Loamy Sand

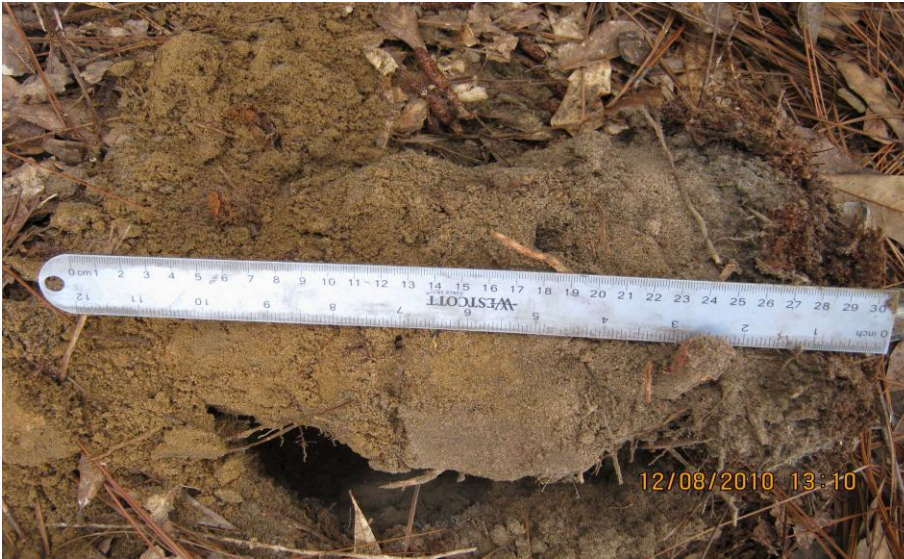
## I. 44 - Troup Loamy Sand; 0-5% Slopes

0-0.5"	Oi	10R 2.5/1 Pine Duff
0.5"-4"	A	10YR 4/3 Loamy Sand
4"-12"+	E	10YR 5/6 Loamy Sand

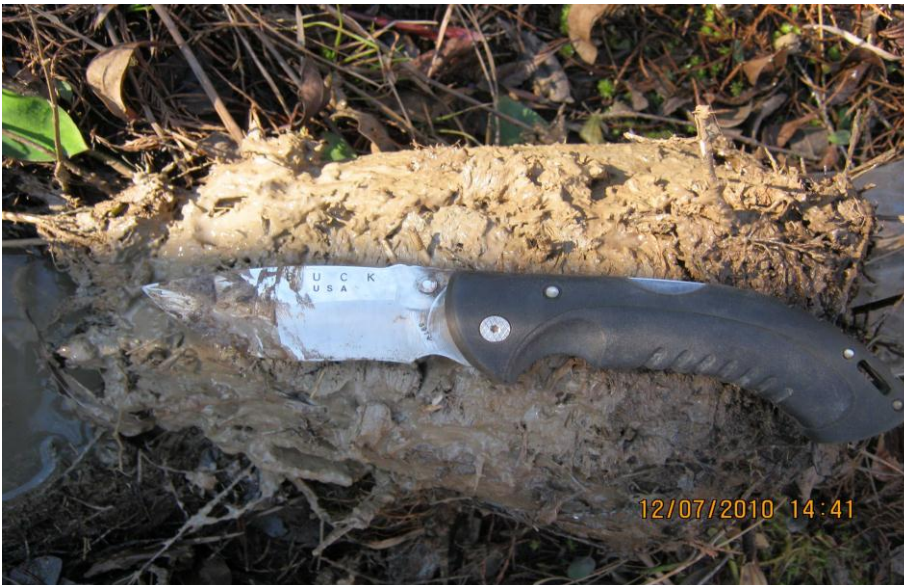
### A. 3- Bibb-Kinston Association

0-1.5"	A	5G 5/1 Leaf Litter Layer
1.5"-12"+	C	5G 5/1 Clay

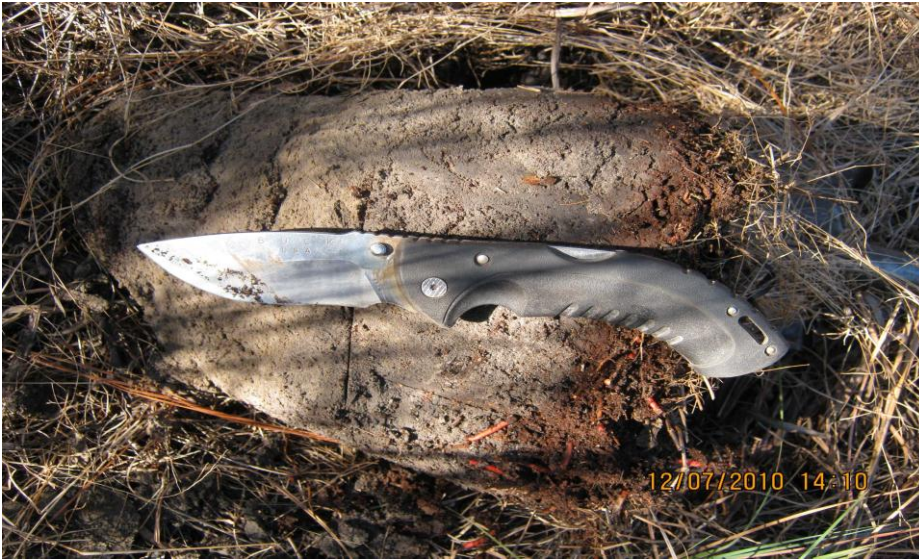
### B. 37 - Rains Fine Sandy Loam

0-1.5"	Oi	10R 2.5-1 Pine Duff
1.5"-6"	A	10YR 4/1 Sandy Loam
6"-12"+	E	10YR 5/1 Sandy Loam w/ 10YR 5/6 Redox

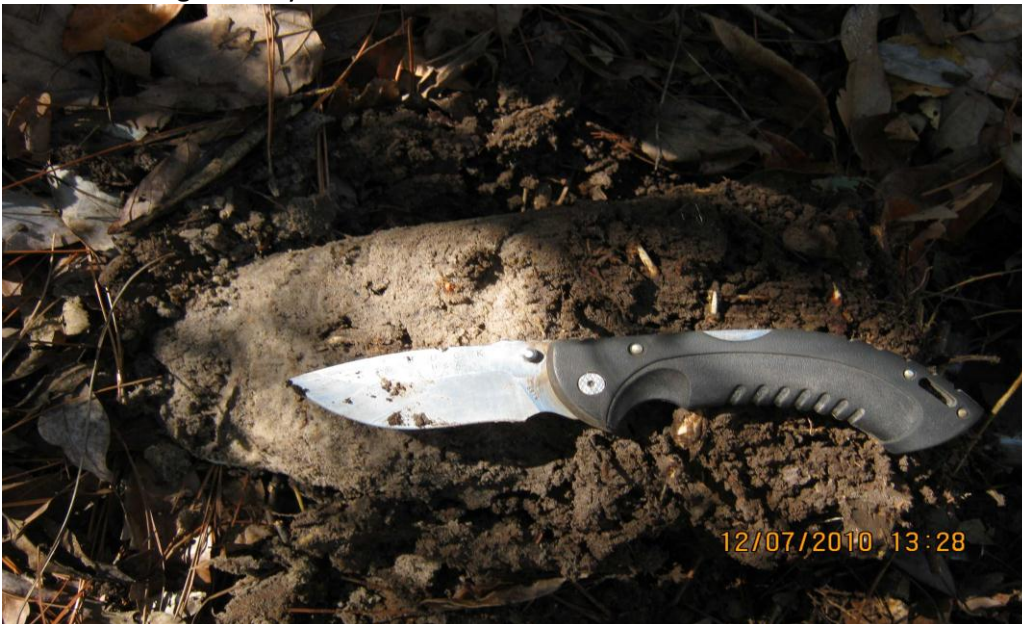
### C. 40 - Rutledge Loamy Sand

0-5"	A	10YR 3/2 Muck
5"-12"+	E	10YR 5/1 Loamy Sand w/ 10YR 6/5 Redox

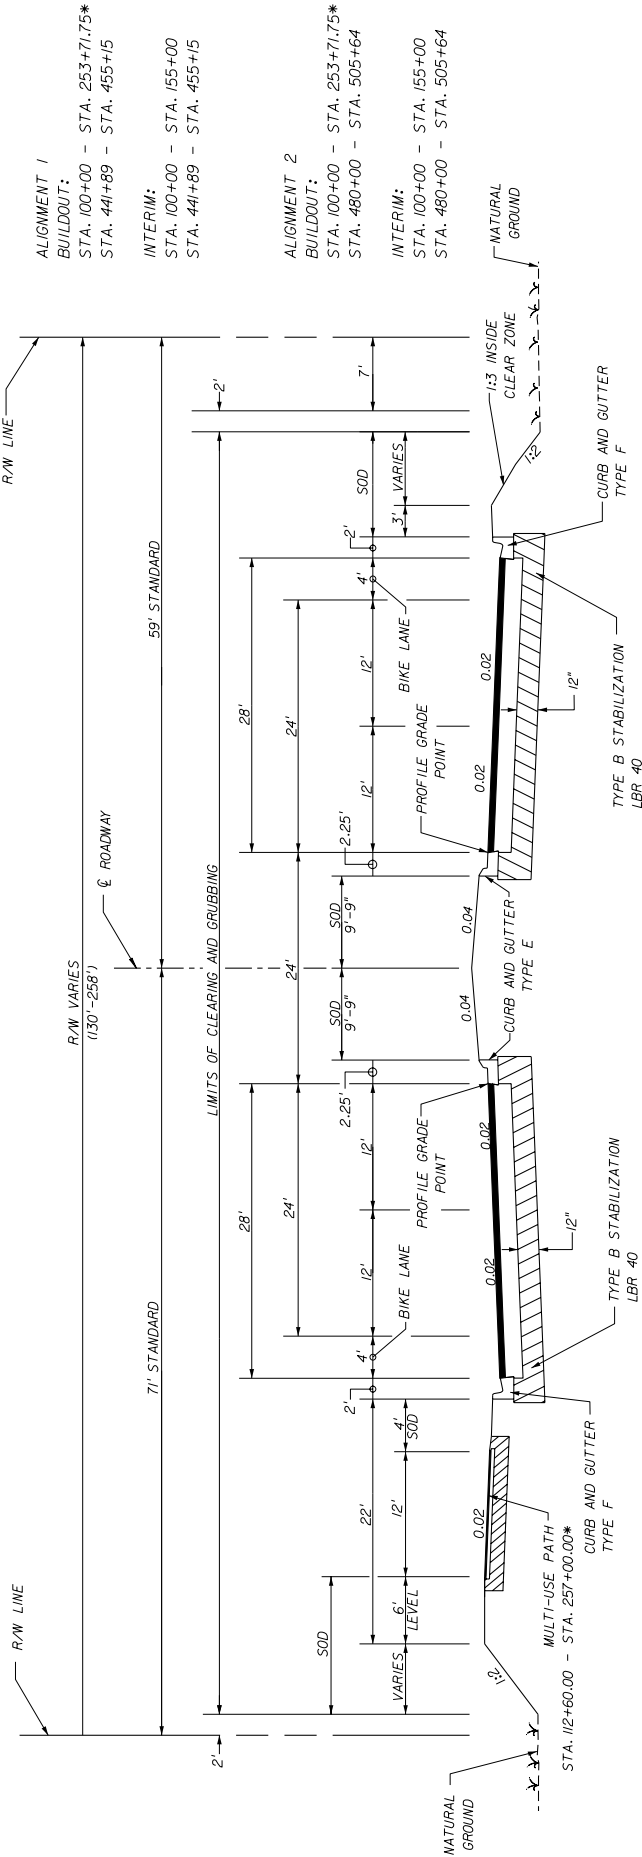
PROPOSED URBAN ROADWAY TYPICAL SECTION

\*FOR AREAS WITHOUT THE MULTI-USE PATH,  
THE LEFT SIDE WILL MIRROR THE RIGHT SIDE

DESIGN SPEED = 45 MPH  
CLEAR ZONE = 24'

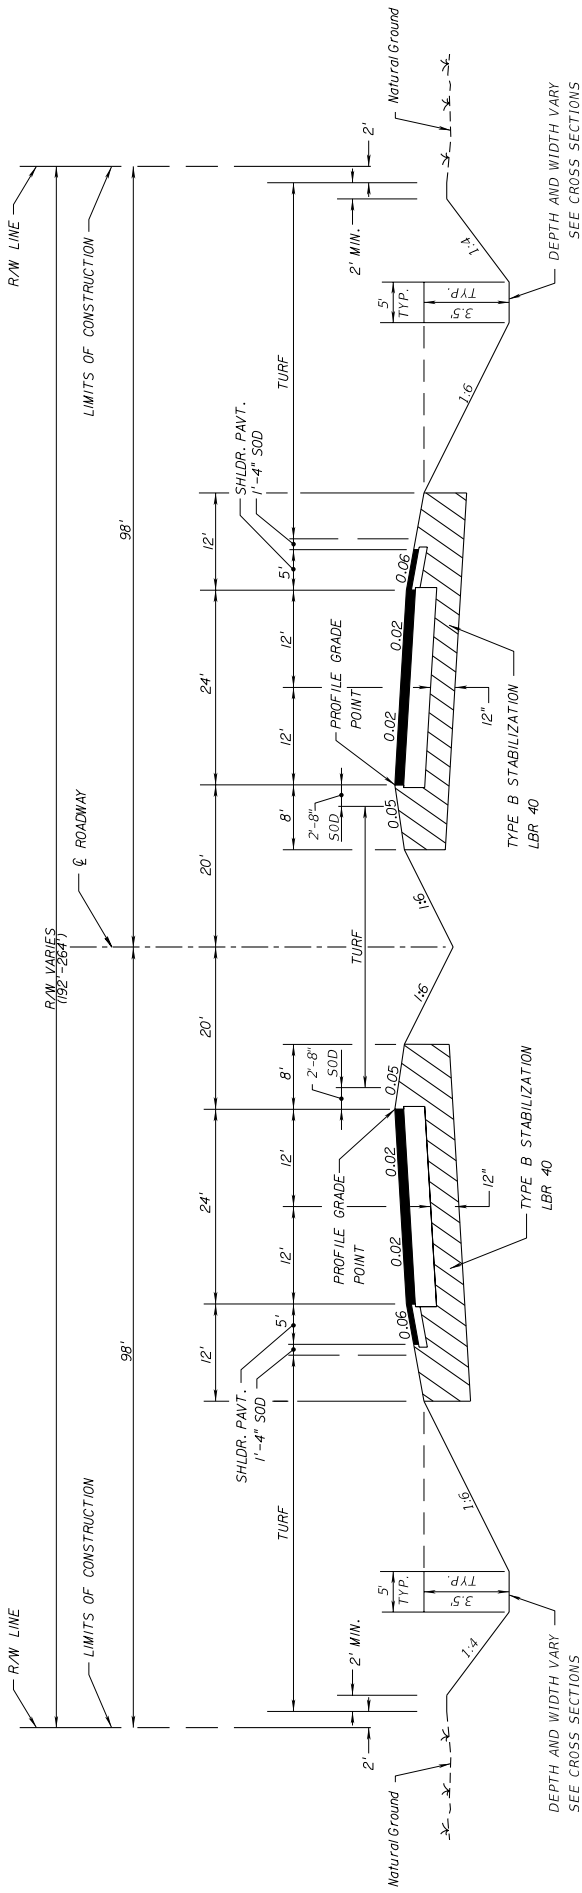
PROPOSED RURAL ROADWAY TYPICAL SECTION

DESIGN SPEED = 65 MPH  
CLEAR ZONE = 36'
